## Architect's Field Report

201 Park Court, Suite B Ridgeland, MS 39157 P 601.790.9432 F 888.281.0547	20 June 2020  18059-AOI Academy of Innovation / Report Number 039
One Jackson Place, Suite 250 188 East Capitol Street Jackson, MS 39201-2100 P 601.352.5411 F 601.352.5362	Contract Century Construction Date / Time 18 June 2020 / 11:00 AM Weather / Temp Clear / 85 ° F Est % Complete 60% Sched Conformance + 68 days Work in Progress Structural Steel Install Interior Framing Mechanical Install
161 Lameuse Street, Suite 201 Biloxi, MS 39530 P 228.374.1409 F 228.374.1414	Present at Site Joey Moore, Century Construction Will Commarato, DBA Paul Purser, DBA  Observations Arriving on site, I met Joey Moore, CC who was just discussing an offset of structural steel in a column line at the North Structure with Will Commarato, DBA. This offset was deemed acceptable.  I walked the interior with Mr. Commarato afterwards. We reviewed framing throughout but specifically at the upper furr down curve in the Main Lobby on the south side of the central structure. The curve is close but still needs some adjusting.  We also discovered an erosion issue at the West Elevation of the North Structure that ne

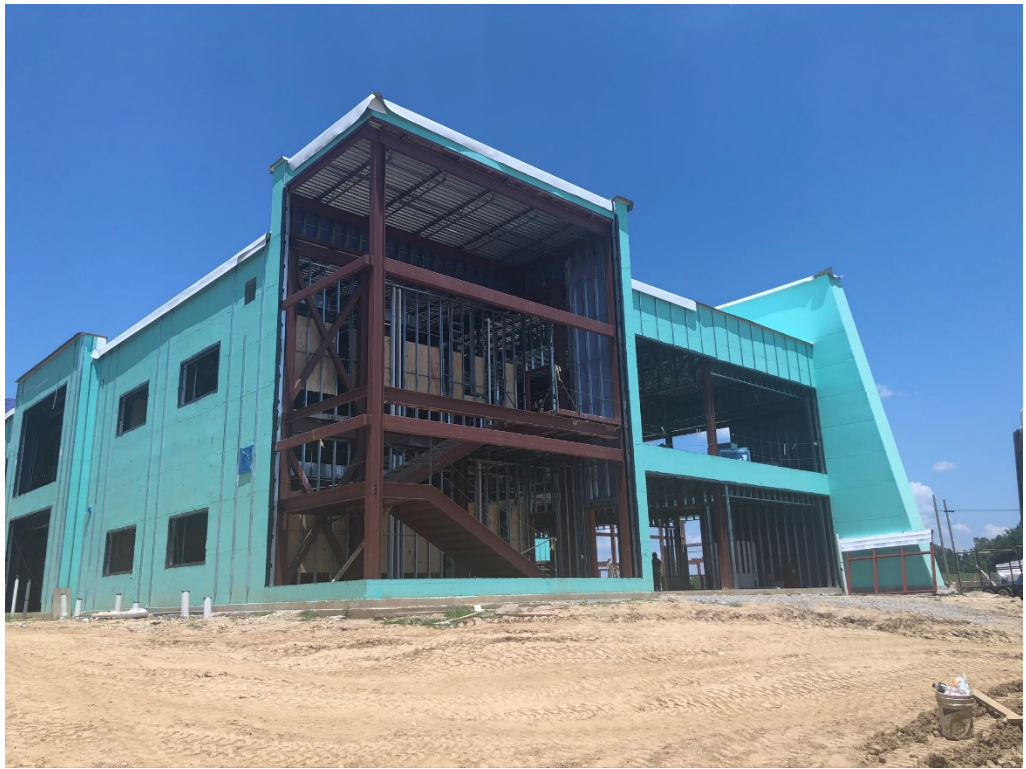
Figure 1 – East Structure

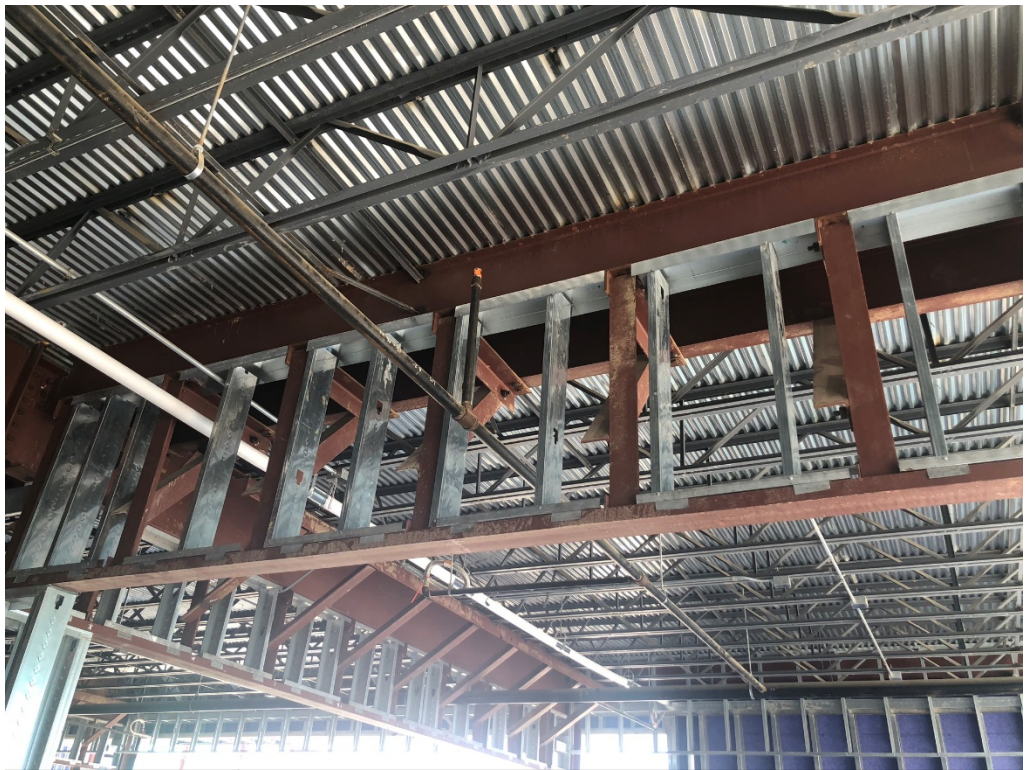
Figure 2 – East Structure Framing

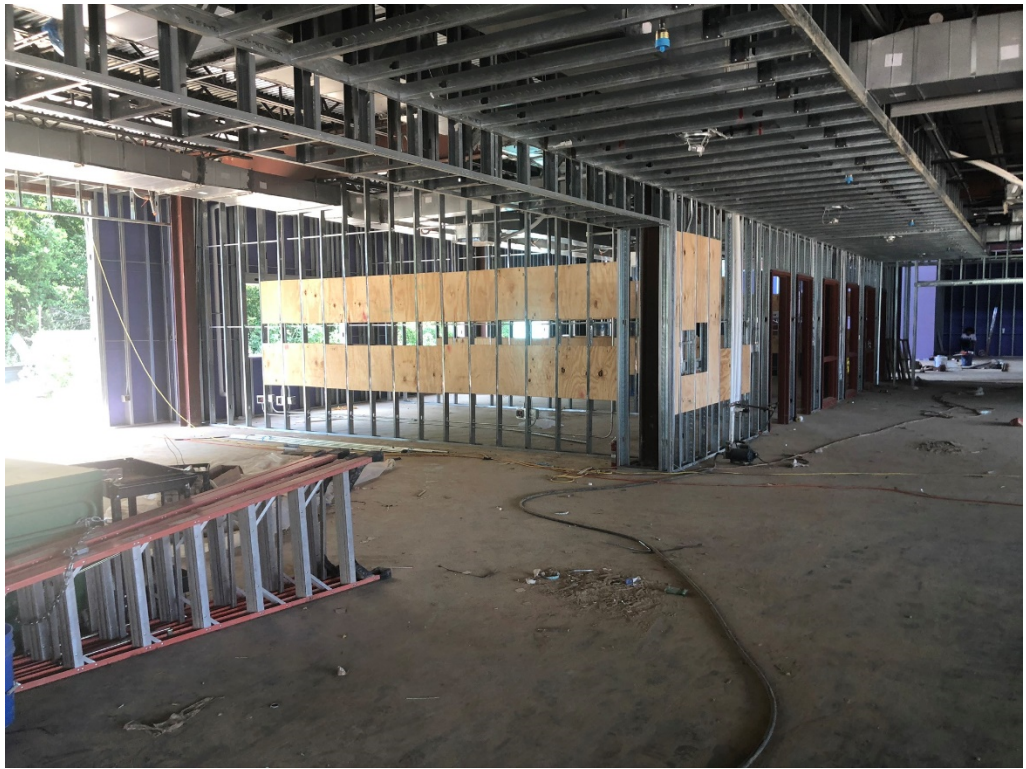
Figure 3 – Blocking in East Structure Ongoing

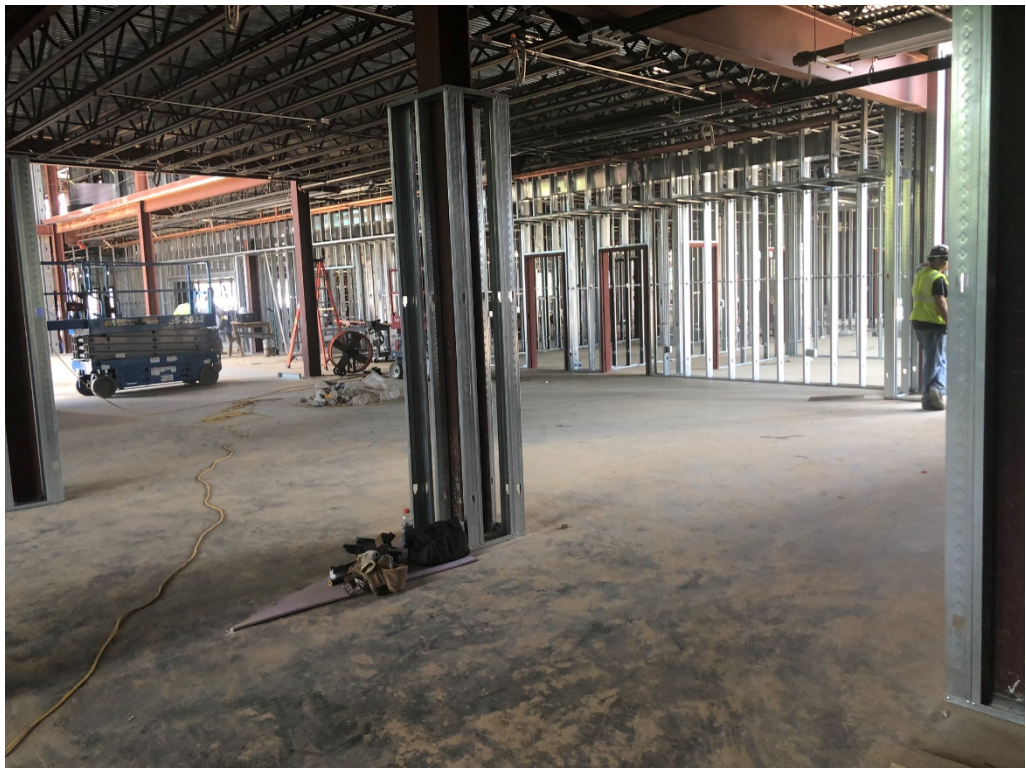
Figure 4 –Interior Framing Ongoing

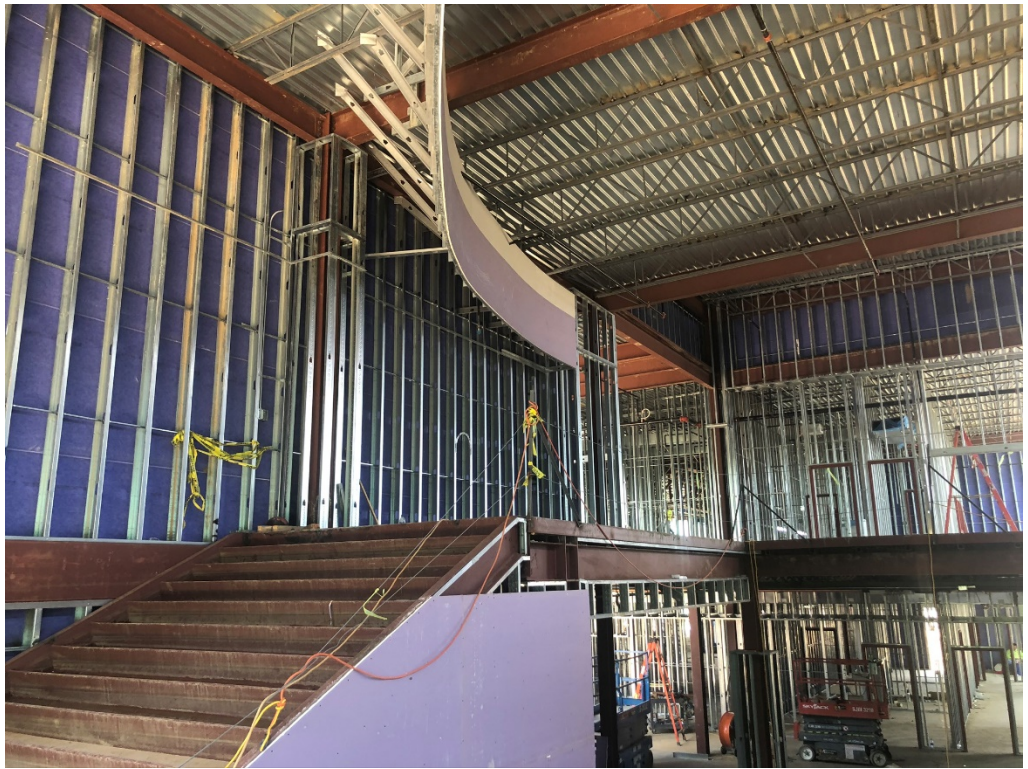
Figure 5 – Furr Down Curve Needs Attention

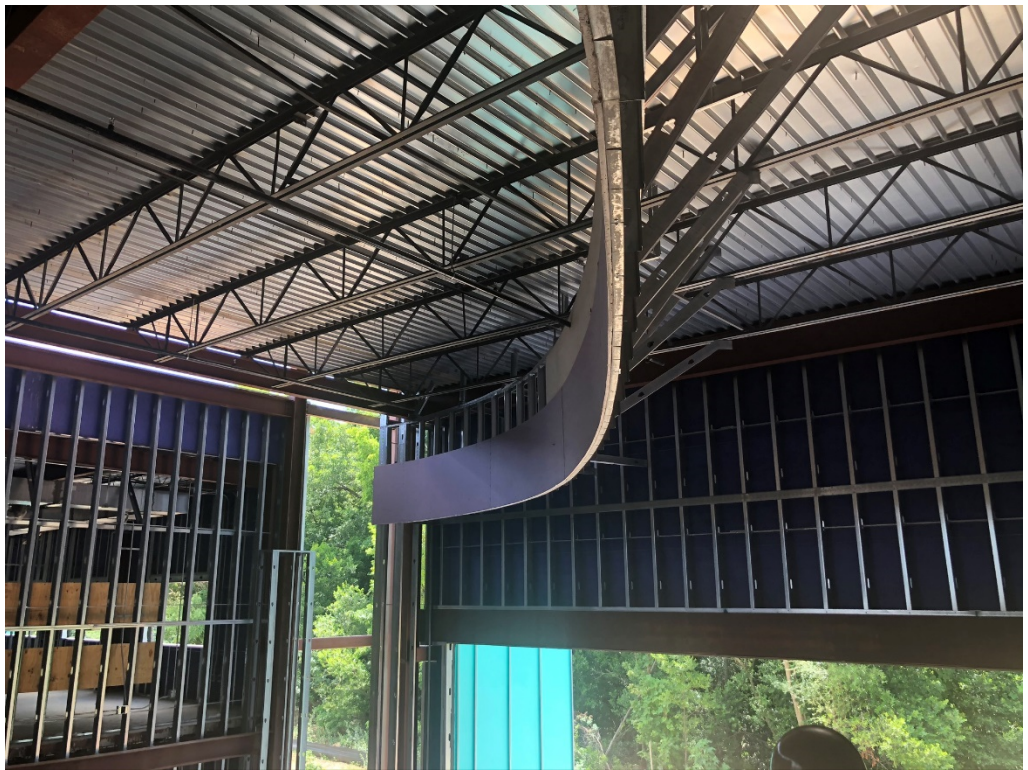
Figure 6 – Furr Down Curve Needs Attention (adjusting required at straightened portion)

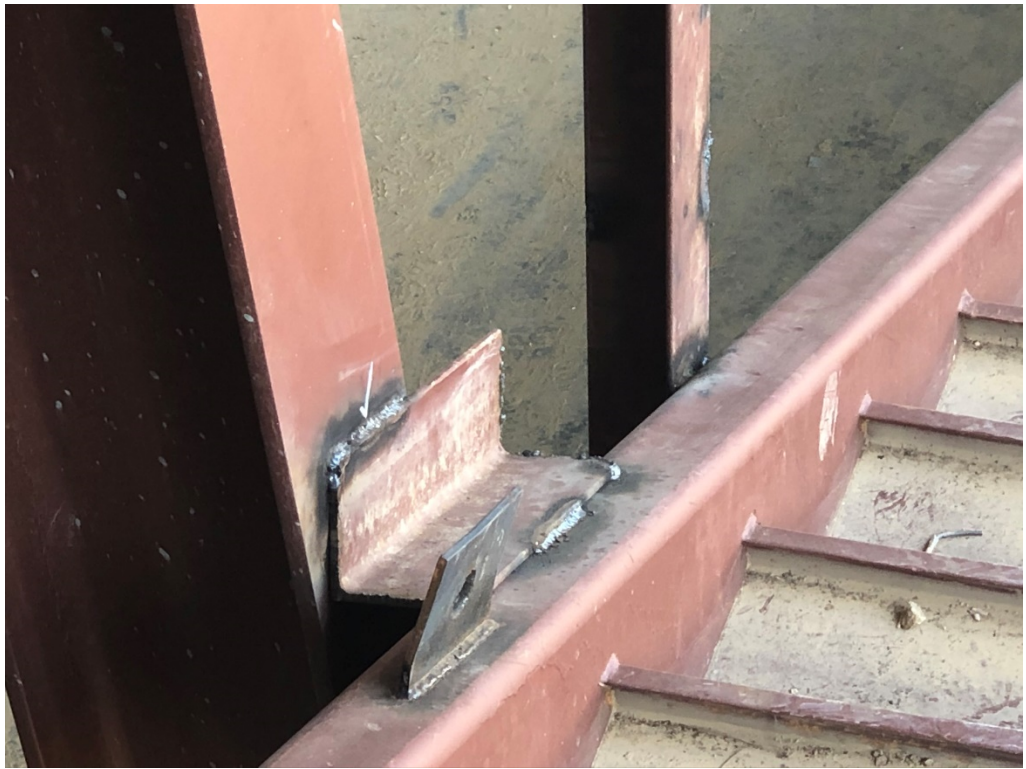
Figure 11 – Unsightly Weld at stair to structure (Assuming this is temporary)

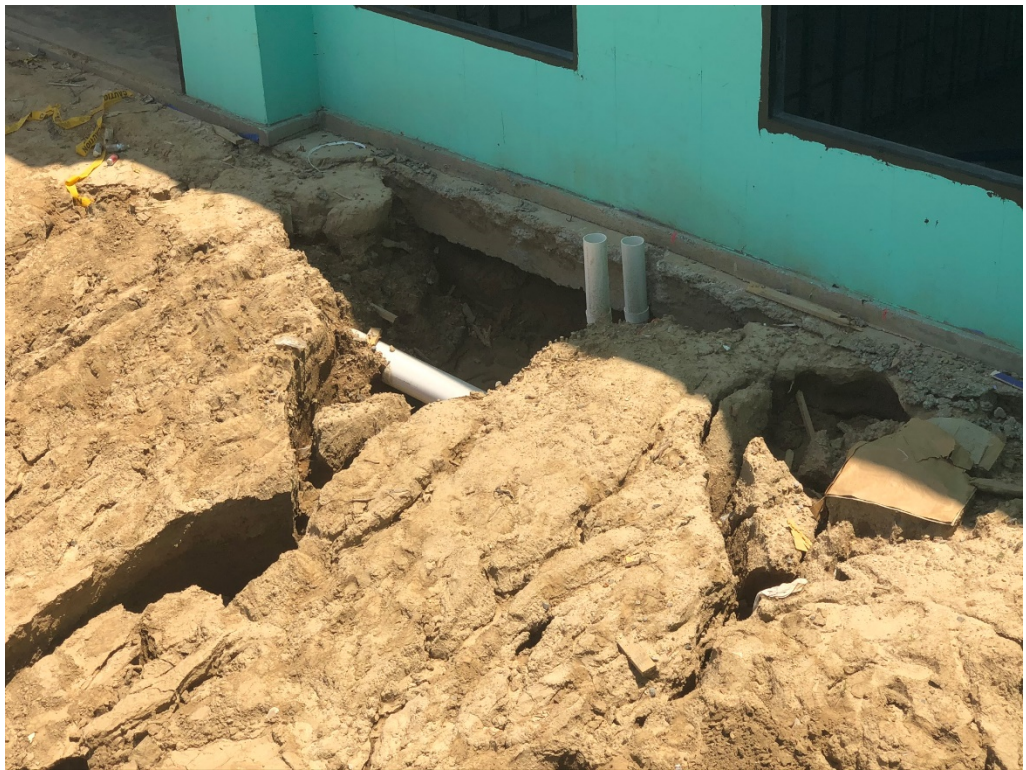
Figure 12 – West Elevation at North Structure Erosion

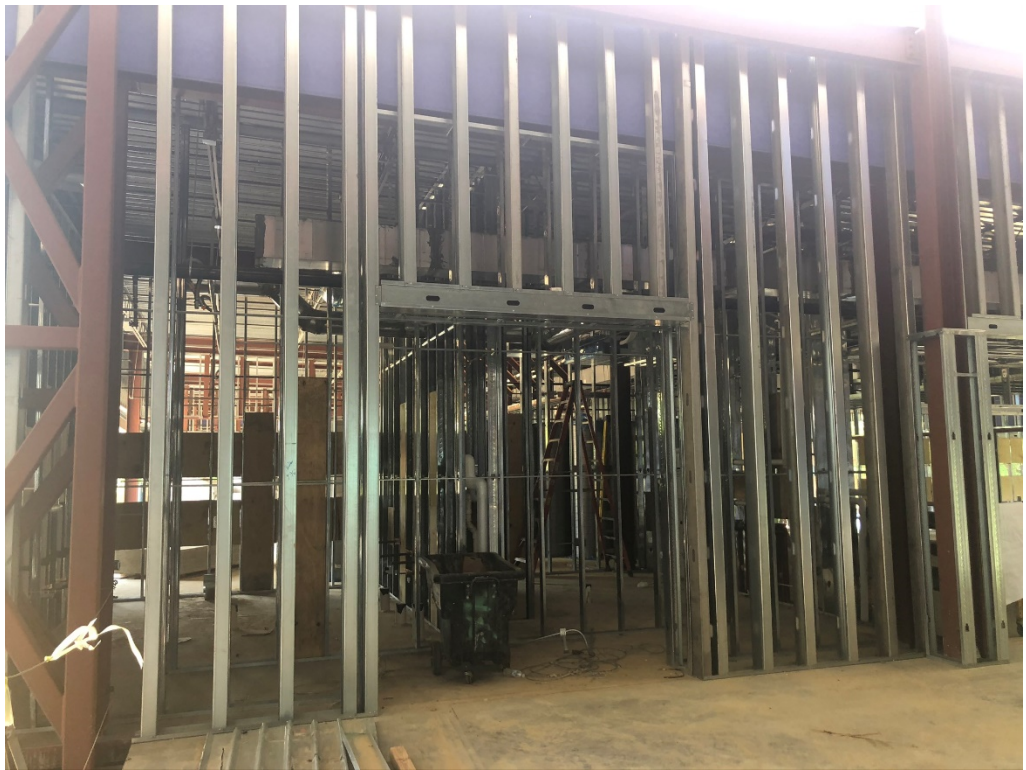
Figure 14 – Secondary Structural Wall Installed Between Central and East Structures

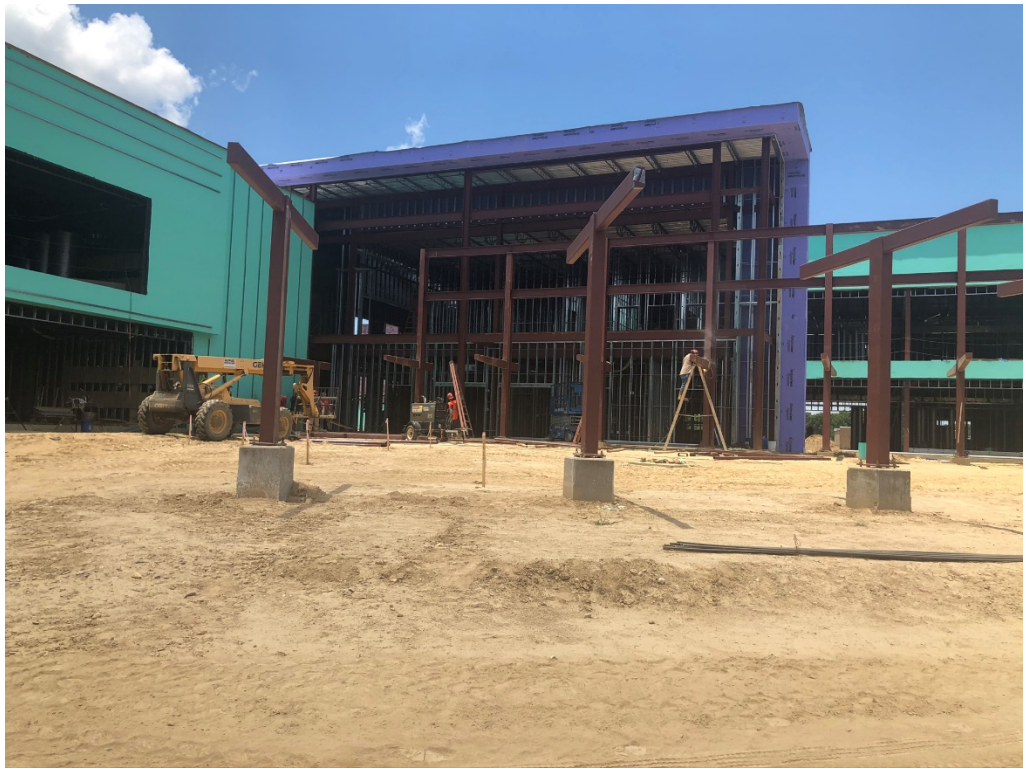
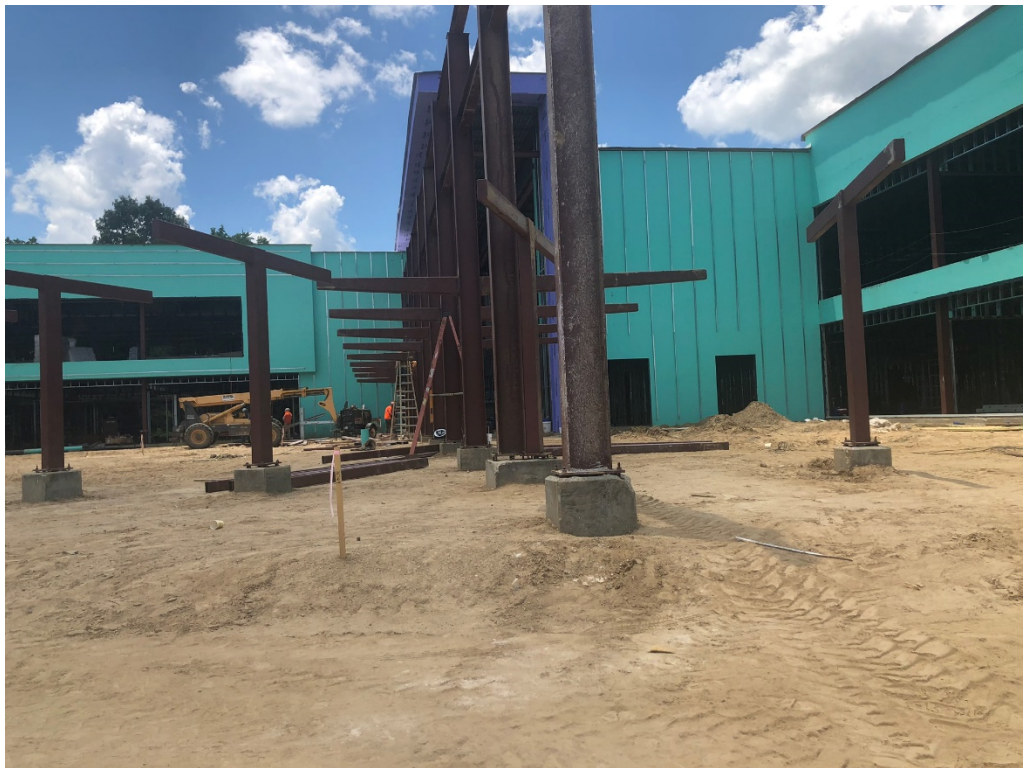
Figure 15 – Structural Steel Welding @ East Façade of North Structure

Figure 16 – Structural Steel Welding @ East Façade of North Structure
